AIRSIDE REVAMP—REFINERY CASE STUDY

# KEROSENE PRODUCT COOLER REVAMP

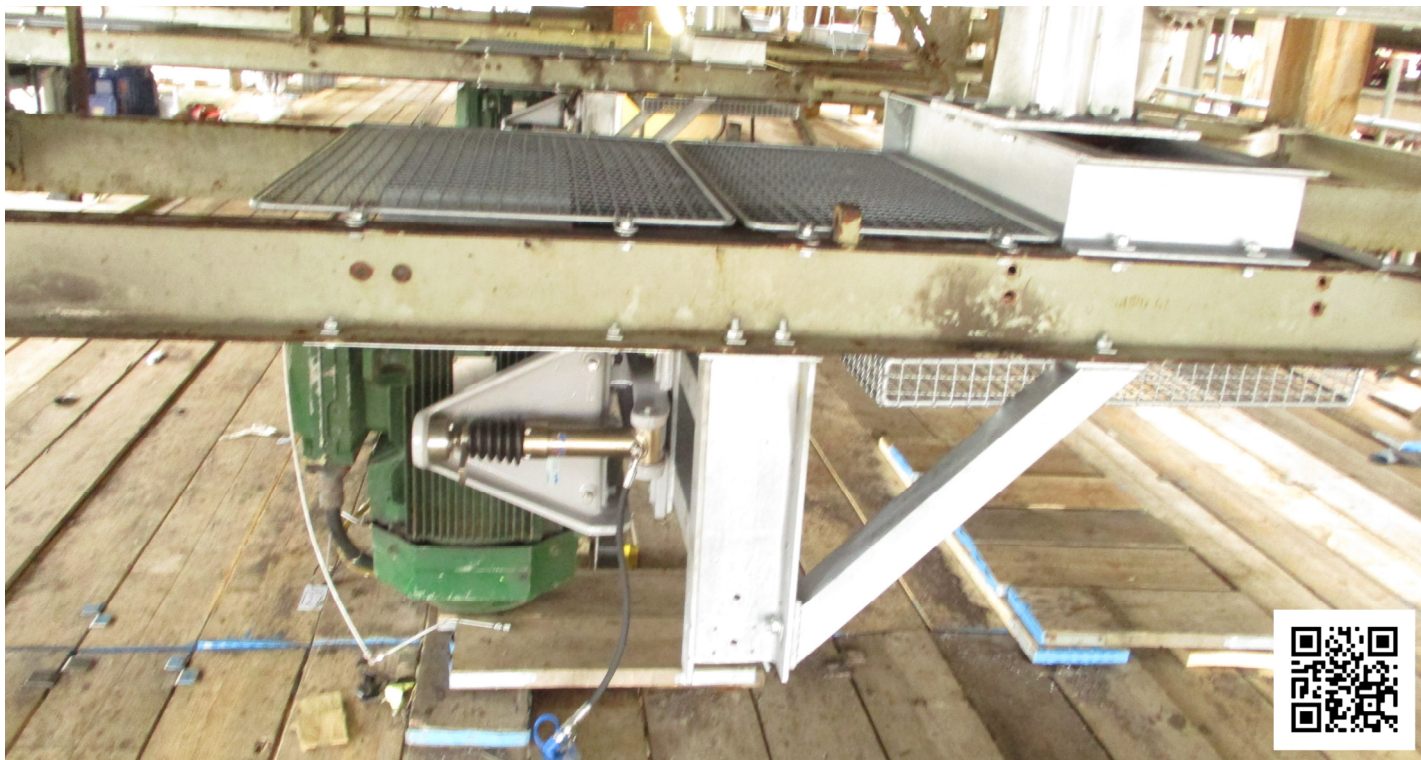
In 2019, Kelvion Thermal Services completed an airside revamp of a Kerosene Product Cooler in the Crude Distillation Plant of a UK refinery. The Kerosene Product Cooler had a higher than design outlet temperature, this is due to the old, fouled and inefficient equipment.

- Airflow was found to at 88% of design,
- The bundles were externally fouled,
- Outlet Temperature was 52.7°C,

- ◆ Complete high efficiency fan,
- ◆ New transmission and belt tensioning device,
- ◆ New fan shaft with top and bottom bearings,
- ◆ New 15kW motor,

New site measurements were taken after the start up of the upgraded equipment. This showed that the airflow had increased by 41.5% and the outlet temperature had dropped by 6°C (from 52.7°C to 46.7°C). Bundles were still fouled and need to be cleaned.
